TS-PIC-92135
December 1992

Site Analysis
North Bronson Industrial Area
Bronson, Michigan

by
David B. Riccio, Imagery Analyst
The Bionetics Corporation
Warrenton, Virginia 22186

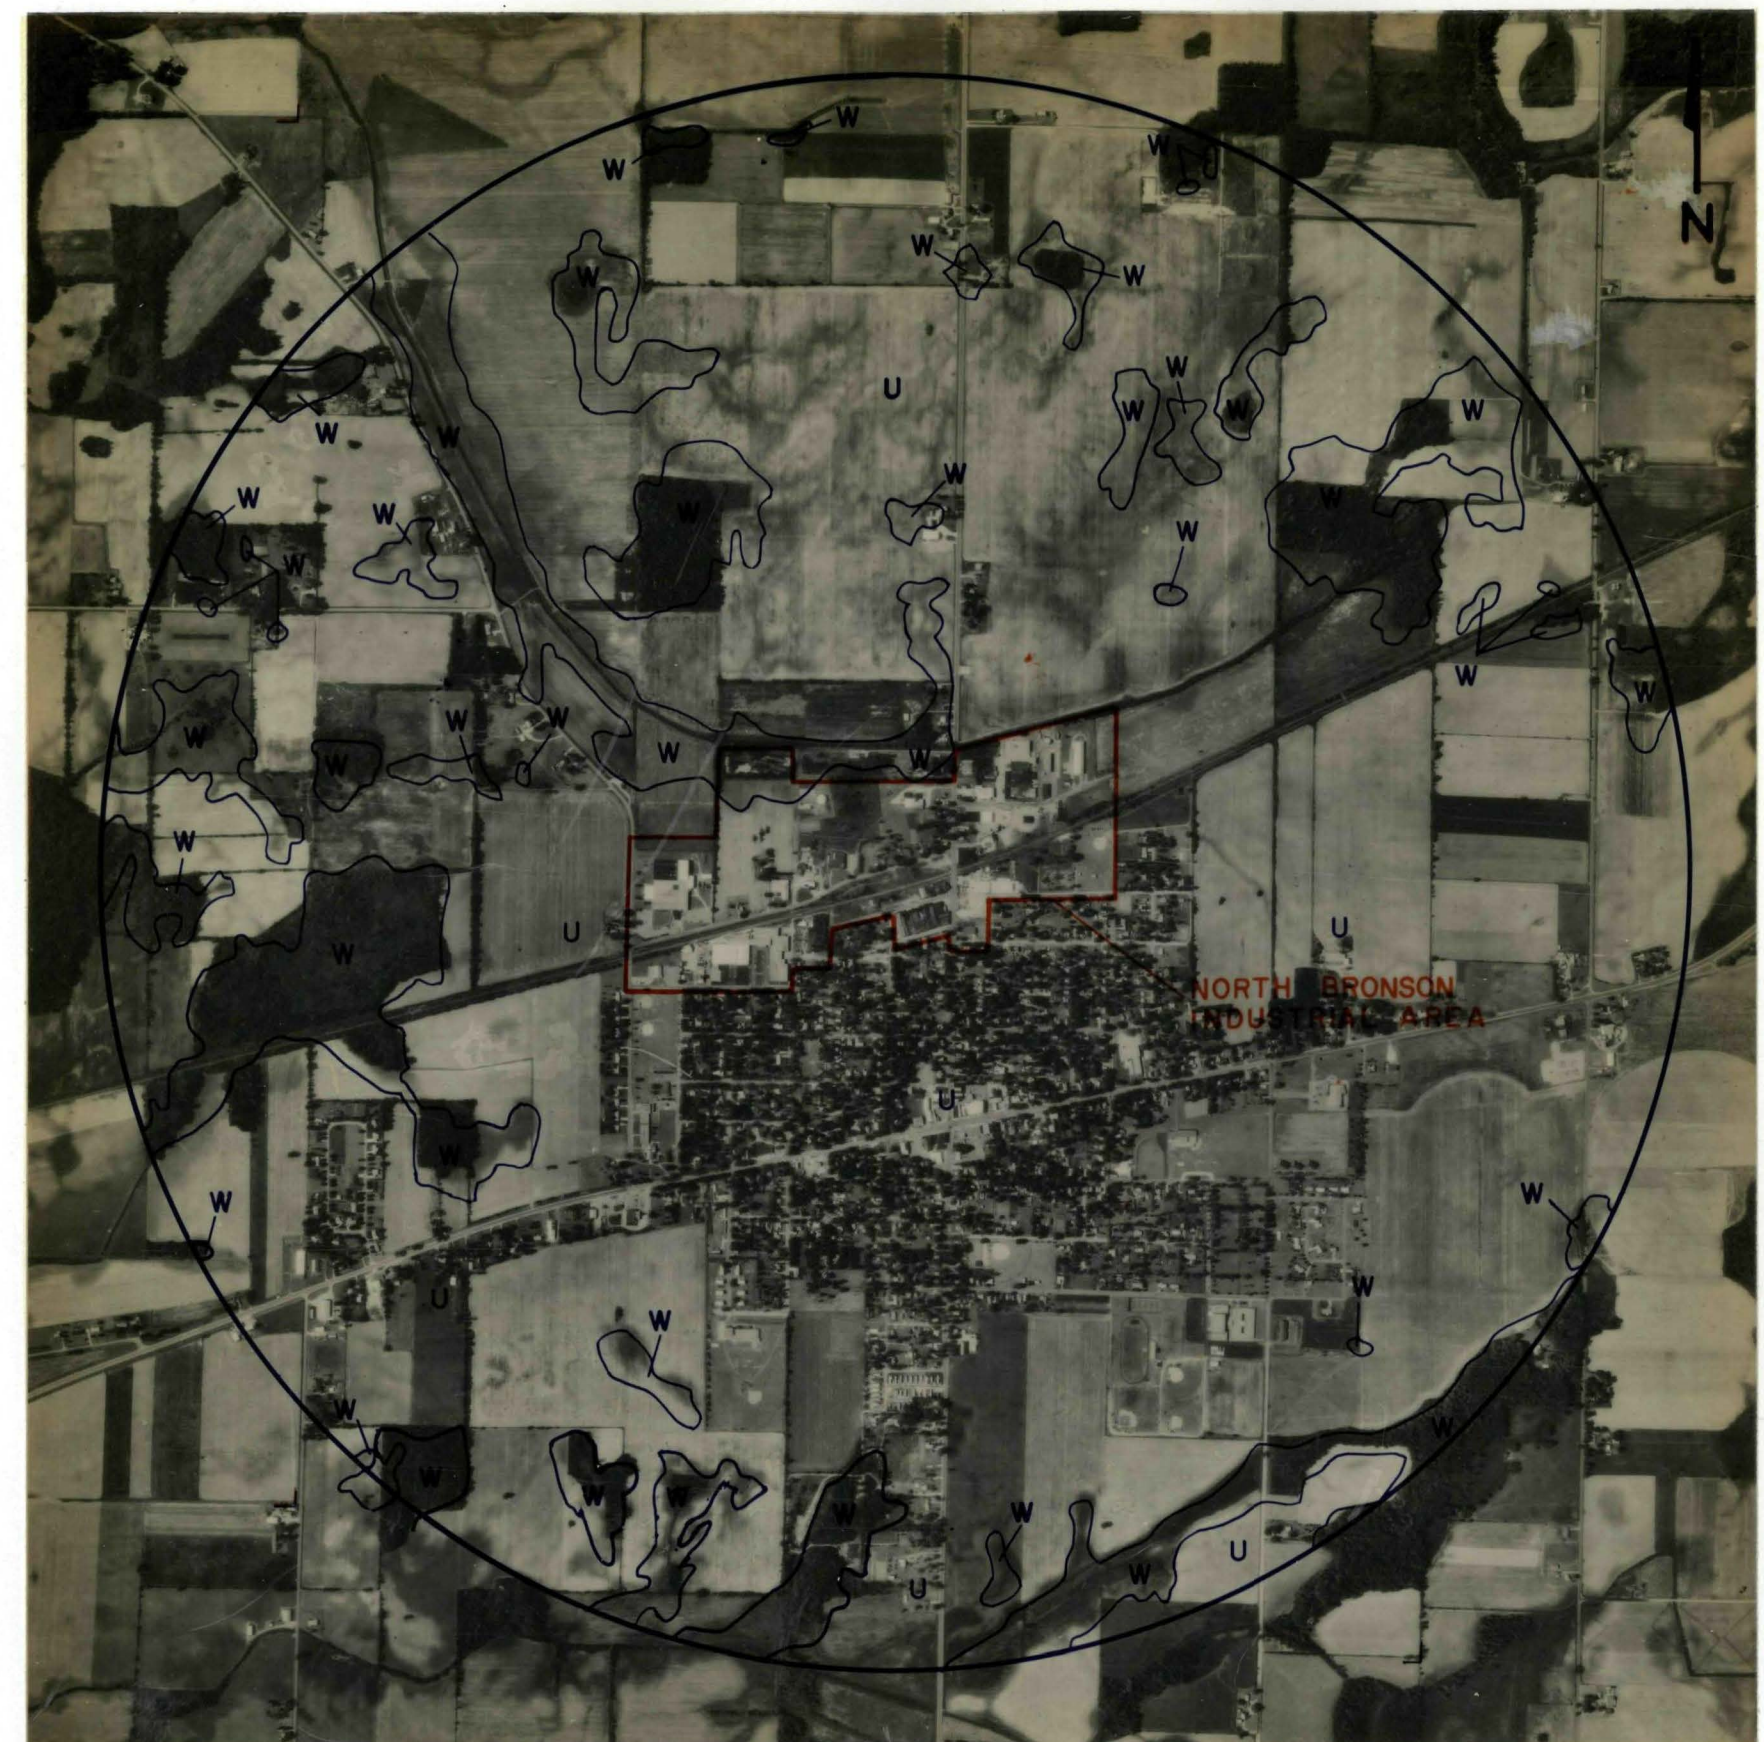
FIGURE 2
N. BRONSON IND.
AREA

The 1988 photography (Figure 2) shows the location of hydric soils from the county soil survey and wetlands delineations from the National Wetlands Inventory Maps for the area within a 2-kilometer (1.2-mile) radius of the site.
